# **ST.ANDREW'S CHURCH, MUTFORD**

## **ORIGINS AND EVOLUTION OVER TIME**

### **A DETAILED & PERSONAL INSIGHT**

**July 2026 v2.7**

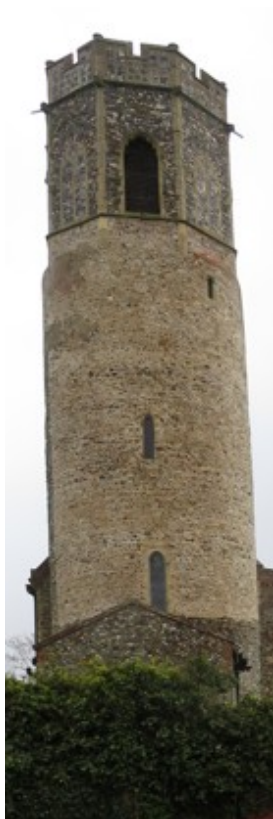
Below the octagonal belfry, the tower has windows at three levels.

*The tower is in reality vertical. So please excuse the Pisa simulation*

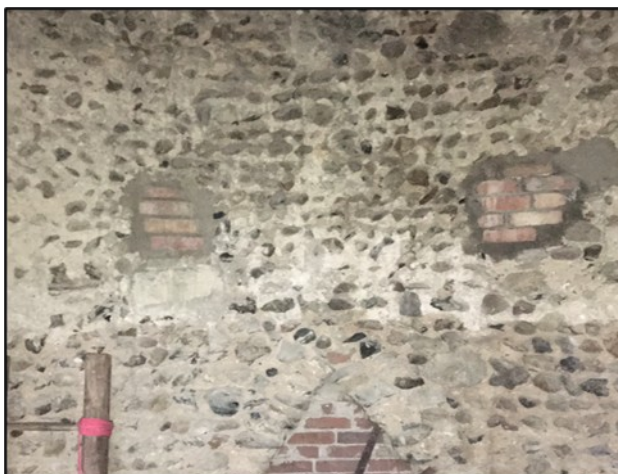
The lowest level would originally have had a floor where the pre c.14 bell ringer(s) would have stood; this has now gone. On the external south and north sides it is possible to see two filled narrow openings (also called loops by some). On the west side, there is a much larger glazed lancet window overlooking the Galilee ridge and this would have been originally the same size as the other two. The enlarging and lowering of this window was probably done during the c.14 rebuild when the Galilee porch was added – and the floor removed.

On the tower's second (middle) level, there are three windows at the compass points, with the north and south blocked and only the west remaining, which is glazed. Brick and stone infill around their arches indicate that they were originally much wider. On the east side facing into the nave is a triangular-topped filled doorway (arrowed) which would have opened below the nave ridge.

The presence of now-filled slots in the stonework on all four sides (see picture on previous page) indicates that these held beams which crossed and held a cage in the centre from which hung a single bell which was rung from the floor below (i.e. level 1). Some of these still have stone corbels protruding slightly from the wall which would have supported the beams.

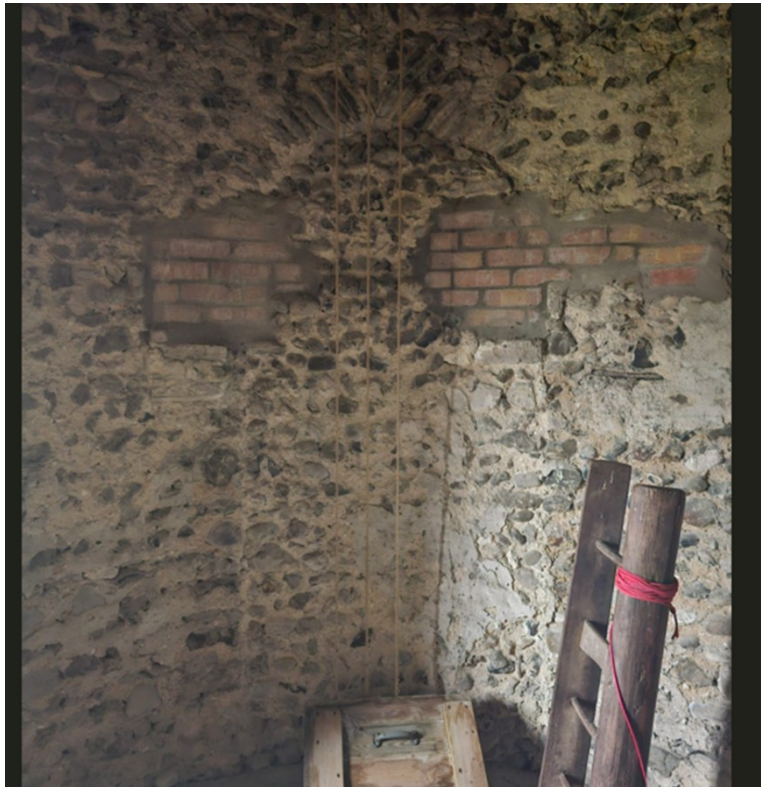
The inside of the tower was repaired in 1976 as it was in a poor state of repair, with modern bricks used in the silence chamber to fill large holes (see below). As stated earlier, these holes were thought to have been used to hold the original bell frame, which would have crossed in the centre and supported a cage containing a single bell, rung from the (now removed) floor.

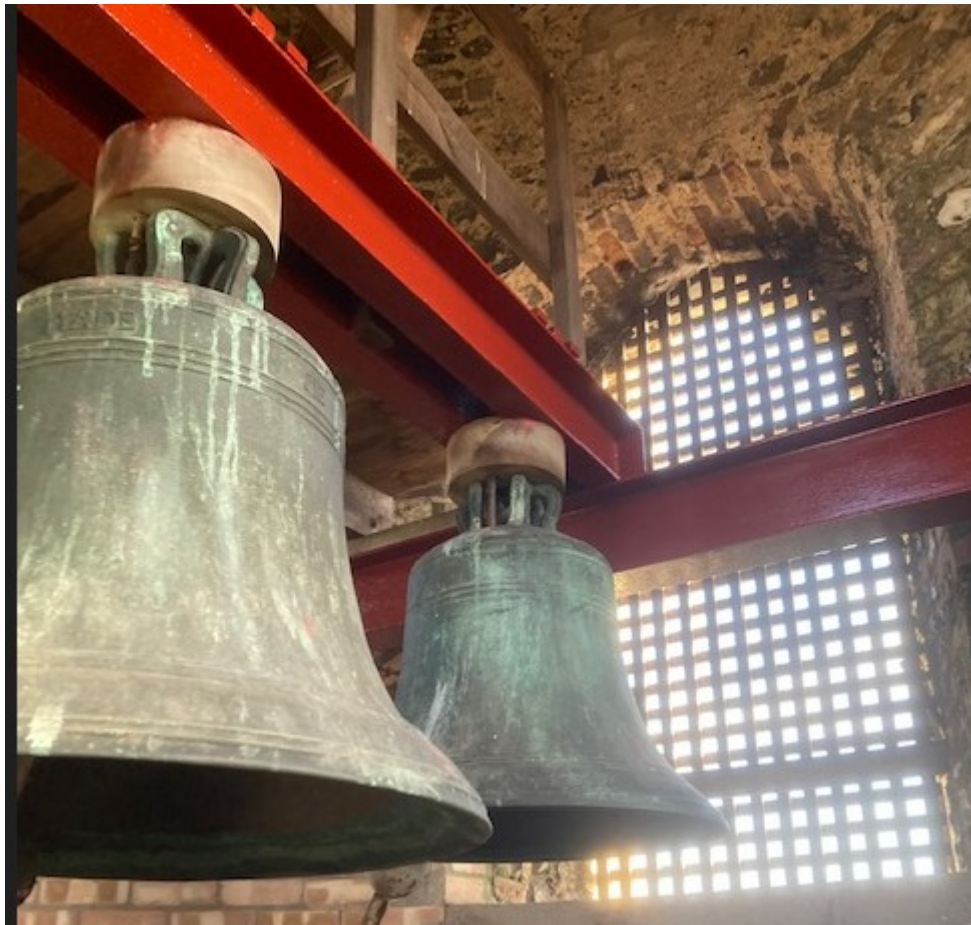
The bells were removed during the 1976 repair work and the existing badly decayed wooden frame replaced by one of steel. The steel frame itself was cleaned and repainted in 2023 (picture on next page).

In 1977, the bells were retuned by Whitechapel Bell Foundry (now closed) and then rehung ‘dead’, which means that they do not move but are struck by a clapper in a fixed position; this was necessary as the foundry felt the main structure of the tower was too fragile at that time to permit the bells to be rung as a peal. Hanging dead is not great for the bells but they are only rung prior to services.

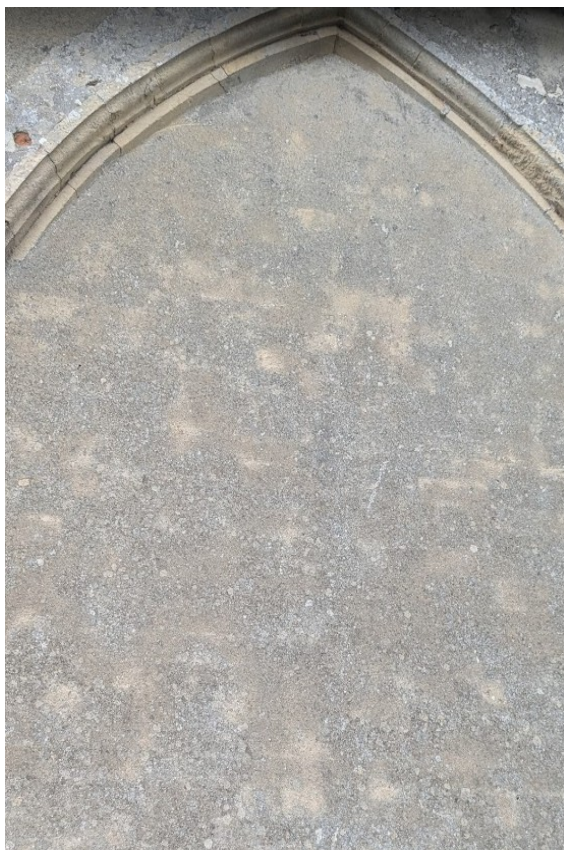
The final window (pictured left) is on the north side. Cauntley asserts in 1937 that this window was originally a very fine c.14 window in the Decorated style, with vertical mullions and was bricked up because the tracery had failed. This puts paid to a local belief that the window had been blown out in WW2; furthermore, this belief was further debunked by the author who spoke to someone who had mapped all WW2 bombs in the area (!), and the nearest bomb was a doodlebug landing a few miles away.

Although the brick filling is now rendered, after rainfall it is still possible to discern the mullions and brick headers beneath the render.

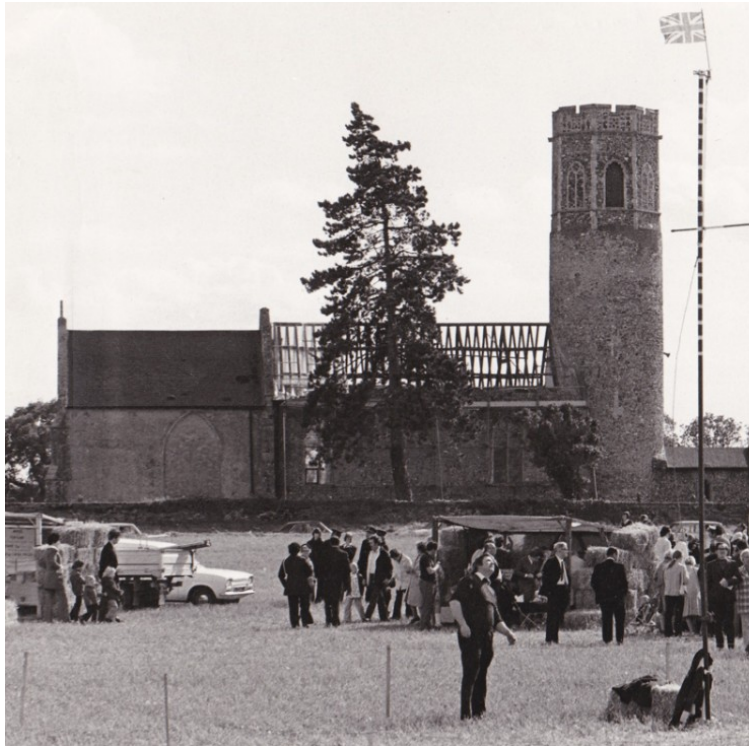
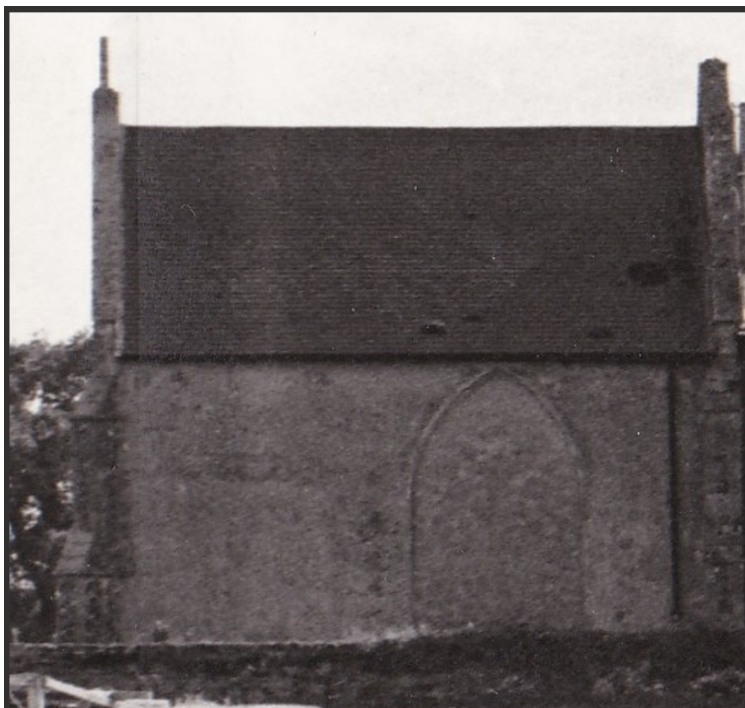
Below is a photograph from when the nave roof was replaced in 1976. The blocked window on the chancel can be clearly seen. When that area is expanded (second picture) the window line seems to go all the way down to the ground, yet there is no evidence of that within the church or of the internal window mouldings (see photo on page 20). One author of an article on the church claimed there was a north transept but there is no apparent evidence for this.

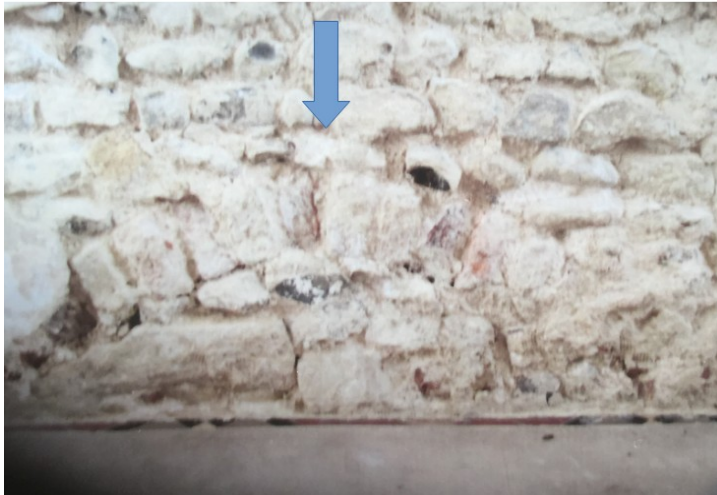
During some restoration work behind the altar in 2015, evidence of a curved arch was noted in the brickwork. The arrow in the photograph (scan of a rather poor printed photograph) shows the top of what looks like an arch.

Several theories abounded when this was discovered: a hidden doorway or a window to allow lepers to receive Holy Communion. However, it is most likely evidence of an aumbry which is a lockable cupboard used to store vessels with the bread and oil used in the service.

The height of the arch is low (1m above the top step) but the three steps at the altar would not have been present in Medieval times so it would have been at waist height. Other things

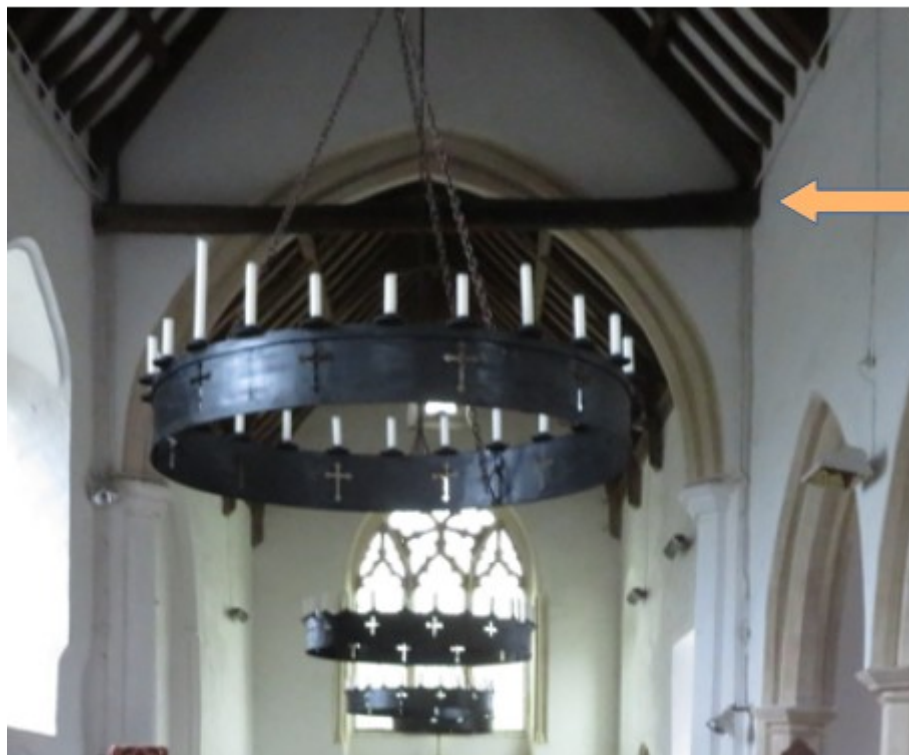
A rood is a large crucifix placed over the entrance to the chancel and often placed on a beam spanning the chancel arch (the rood beam). The beam referenced is assumed to be that depicted below, but seems very high and may have been raised when the nave roof structure was changed in 1881, the 1920s or 1976. We will never know as there are no records I could find.

*'Much woodwork of various periods decorates the interior of this spacious house of worship and amongst this must be mentioned the old rood beam across the chancel arch, in which can be seen the nails which originally supported the figure'.*

One commentator records that “remains of the rood screen are probably incorporated in the modern tower screen”. it is more likely that this was the simple wooden screen from a later time as the wood is not c.15. Part of this screen was moved to the screen separating the tower from the nave in 1976 when the nave roof was replaced as there are pictures of it in situ in 1950 (see arrows on the next picture).

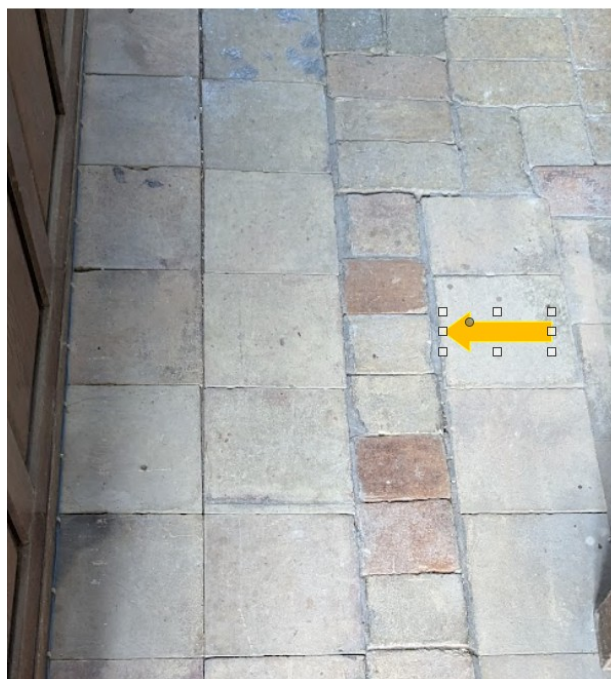
At the east end of the aisle in front of the decaying Victorian organ, square pammments have been used instead of Gault bricks. There is also an odd line of half-bricks in front of the first bench (arrowed below) and it is not clear why. It cannot be for a parclose (screen restricting access to the chapel) because the sedilia (niche in south wall for a seat) would have been left outside the screened area. It also cannot have been for the Victorian organ as that arrived here in 1951. The best suggestion is that the pammments were laid from the east wall and also against the existing Gaults on the west. Where they met, was a gap and rather than break a pamment, the builders decided to break bricks.

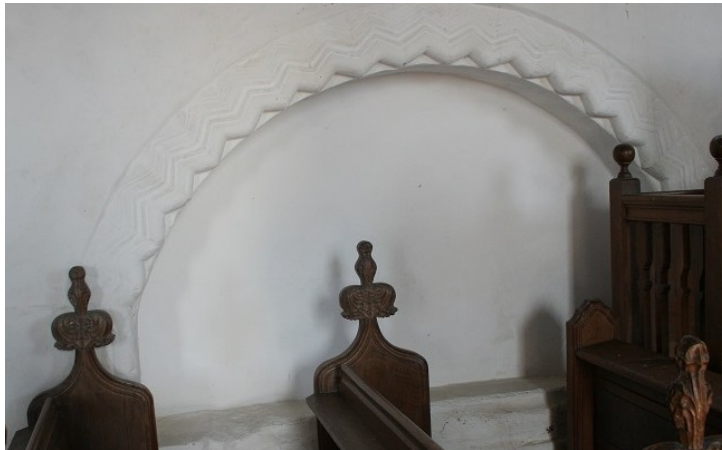
The Norman style chevron moulded arch in the north nave wall shown below is described by Historic England as likely being a memorial to the founder of the church, identified as Balderic de Bosco (born c.1140) or his daughter Hilderberga. This would imply that the church was founded or re-founded in the c.12.

Some sources state that the stones could have come from the original tower arch as the measurements fit. Alternately this arch could have been the original chancel arch before the rebuild as these arches were both originally significantly smaller.

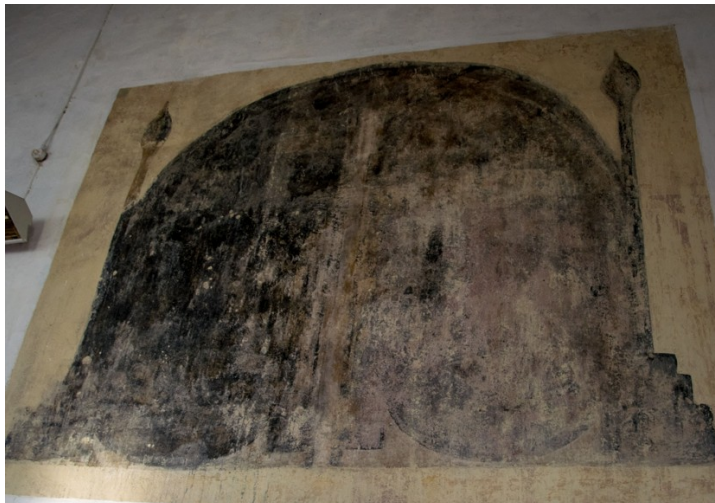
The painting in all its ghastliness

Members of the church congregation in the 1980s remember being able to discern some detail (but not to the level described by Mee), but the use of paraffin and later calor gas heating damaged the paintwork through condensation, resulting in what you can now see, which is not a lot.

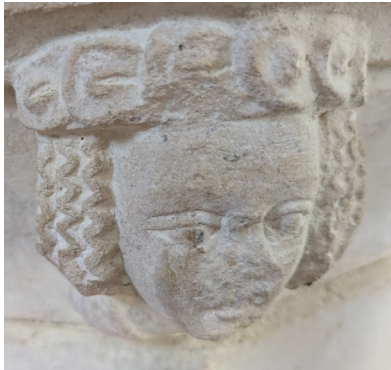
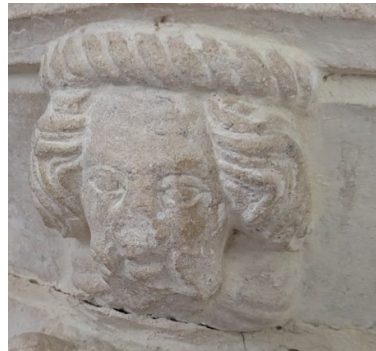
Above the lions at the base of the pedestal are carved heads which a visiting historian informed me are likely to be 'patrons of the font'. These would be images of people who paid for and donated the font. The eight heads alternate between female and male figures and their headgear is consistent of a date of the late c.14. Below are pictures who may represent Elizabeth and Thomas de Hemgrave.

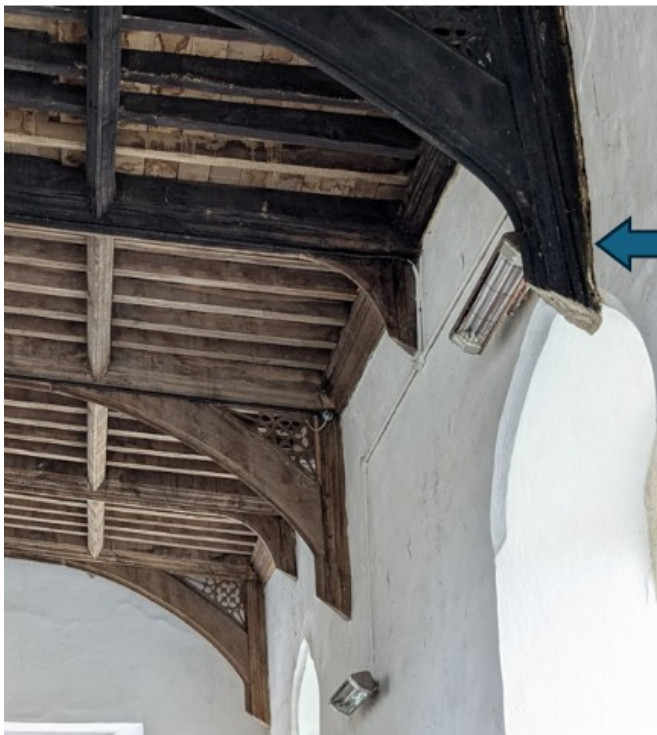
The roof timbers of the aisle are interesting as one of the wooden supports drops over the window opening (arrowed below), not something which would have been designed.

It has been proposed that the timbers were reused from another building. This probably happened around 1696 when the chapel was demolished, and extensive repairs made at that time.

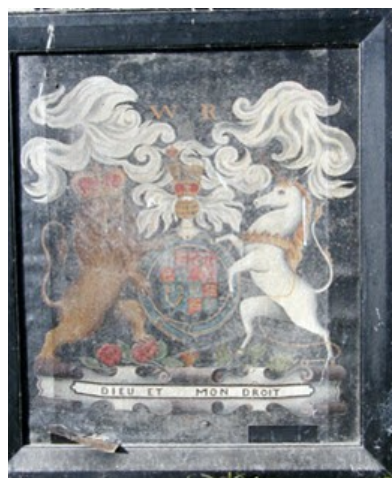
The arms above the south door of displays the royal initials WR. As the frame is bordered in black, it has been proposed that the arms represent King William IV and that the frame was blackened to commemorate his death in 1837.

However, the arms are that of the Stuart dynasty, not Hanoverian. Discussions with the Diocese gave two options: the cipher was overpainted to save money when the monarch changed, or the wardens found a cost-effective local artist who only had the Stuart arms to work with. Close examination of the paint revealed no overpainting, so it looks like the second option, especially as the writing quality of the motto is poor.

Cautley in his 1934 publication "Royals Arms and Commandments in our churches" stated that the painting displays a date of 1831, but for a long time I could find no trace of this date. Fortunately our treasurer who is an accountant (and so has a keen eye for figures), spotted the date at the foot of the painting.

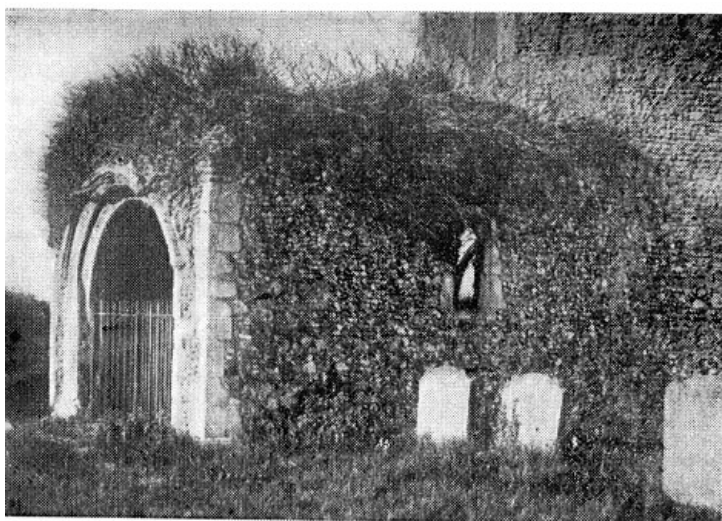
GALILEE PORCH, PROBABLY THE ONLY ONE ATTACHED TO A ROUND TOWER.

"This is called a Galilee, and is almost a singular instance of such an erection in this county. Here the penitents used to sit, while they waited their readmission into the church; and this may account for the name, by which such porticos were anciently called, the Galilee. As Galilee, bordering on the Gentiles, was the most remote part of the Holy Land from the holy city Jerusalem, so was this part of the building, most distant from the sanctuary, occupied by those unhappy persons, who, during their exclusion from the mysteries, were reputed scarcely, if at all, better than heathens"

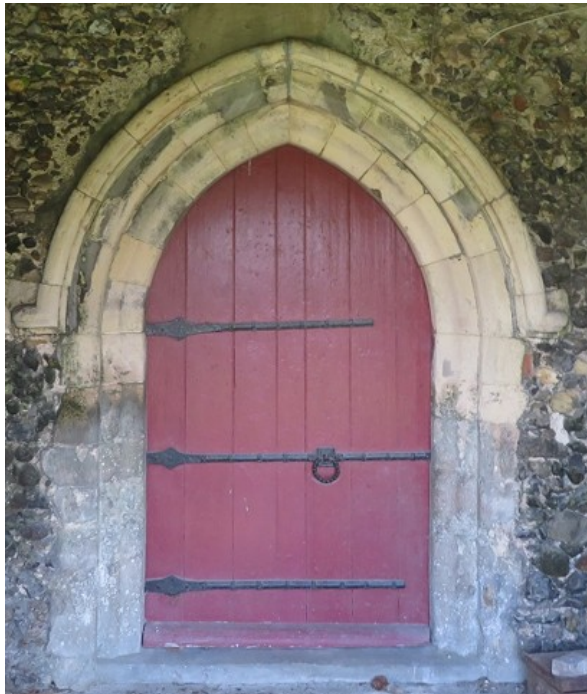
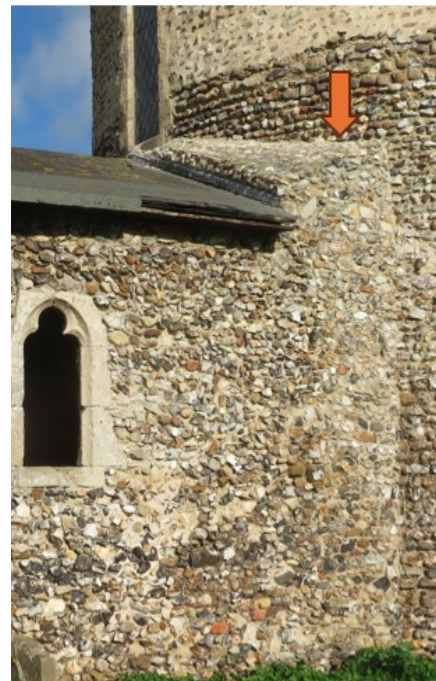
The doorway into the tower was either inserted in the c.14 rebuild or an existing Norman door altered and the Early English Gothic arch added (left hand picture). When the porch was added, in order to create a flat surface for the east end of the porch, a flint & mortar infill was set against the tower (known as a fillet) and this is shown arrowed in right hand picture.

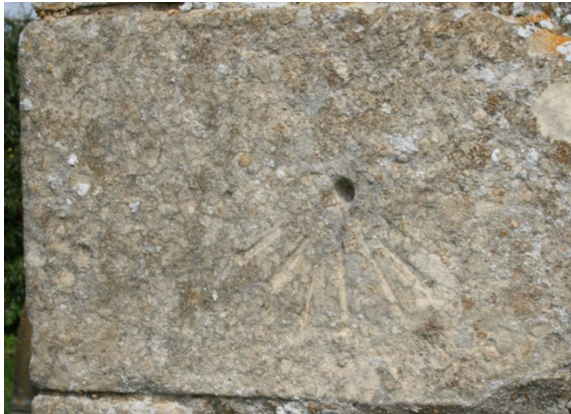
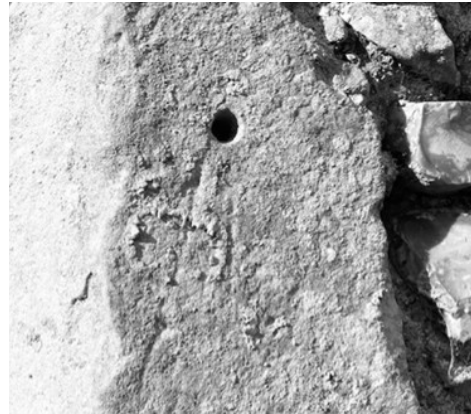
A 1937 list of mass dials in Suffolk (Rev. H.A. Harris) states that St Andrew's had two such dials on the Galilee porch. There is a suspiciously round hold on the right-hand jamb of the south Galilee window (right hand photo) which could have been for a gnomon, indicating the possible presence of this second dial but there are no definitive markings.

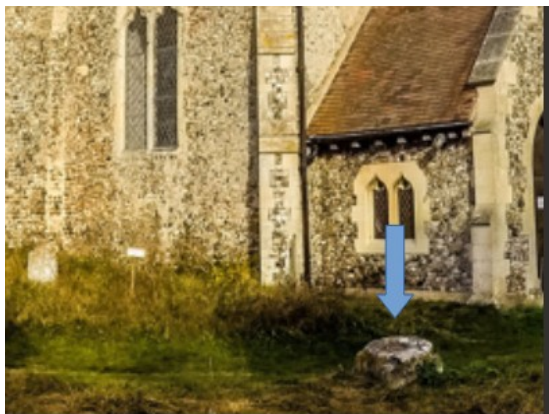
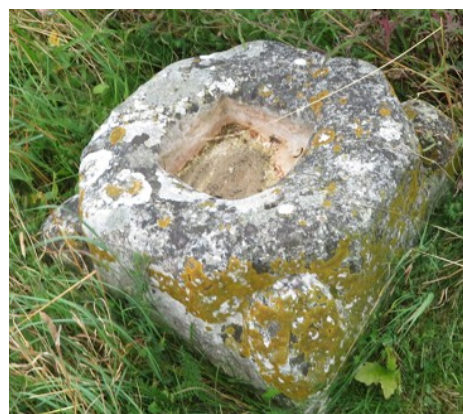
An on-line search reveals there are many churches with such stones near their south entrances and some of these still have permanent stone crosses. These crosses would be way points in processions such as on Palm Sunday or at Rogationtide. If this was a permanent cross, to keep the shaft of the cross in place would likely require the bottom section to be wider with a flange to fit onto the base stone whilst a tenon fits into the hole.

My suspicion is that this stone was imported from elsewhere as there is no mention of it in any of the records I have.
